# The Performance of Carbon Fibre Reinforced Polymer Strengthening During a Real Fire

# THE PERFORMANCE OF CARBON FIBRE REINFORCED POLYMER STRENGTHENING DURING A REAL FIRE

*Tim Stratford, Martin Gillie and Jian-fei Chen*  
*School of Engineering and Electronics, The University of Edinburgh*

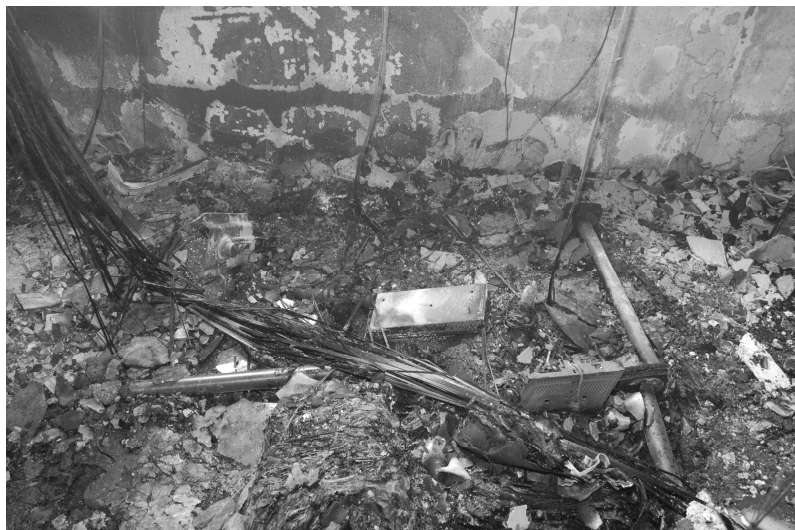
**Figure 5a: Remains of unprotected plate**

- The unprotected plate (figure 5a) had completely separated from the concrete. Both the bonding adhesive and the matrix polymer had burnt away, leaving exposed concrete on the ceiling and the fibres exposed on the floor.

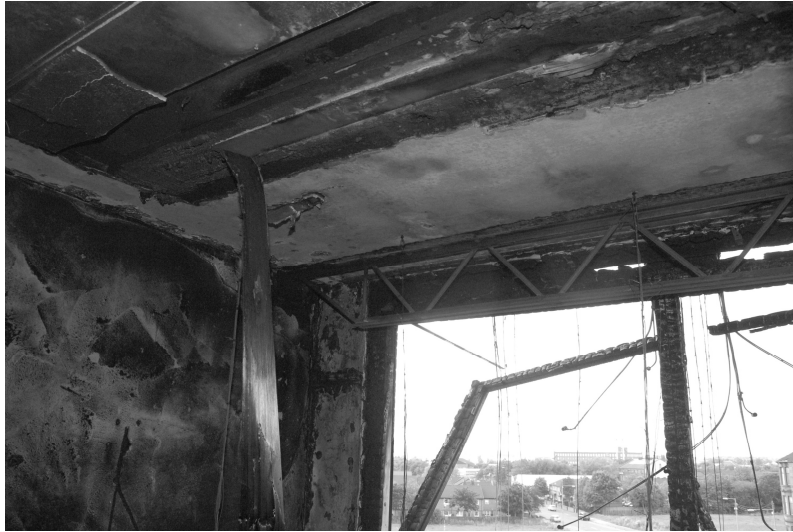
**Figure 5b: Remains of intumescent-protected plate**

- The intumescent protected plate (figure 5b) separated from the concrete, except for a short length at its southern end, where it remained bonded to the concrete. Away from this end, the matrix polymer had burnt away to expose the fibres. The bonding adhesive was charred, but remained on the ceiling.

Nevertheless, the uncorrected strain evolutions in Figure 7 are useful. Separation of the intumescent plate from the concrete, for example, occurred about 10 minutes from the start of the test, but the plate remained in contact at the southern end (confirmed by Figure 5b). The gypsum board protected strengthening have complete strain traces. The negative strains for the north gypsum-protected NSM gauge suggest the FRP has slipped relative to the concrete slab due to adhesive viscosity at high temperatures, but solidified during cooling. Further work, however, is required to analyse these results.

The intumescent protection was ineffective, due to an activation temperature that exceeded the glass transition temperature of the adhesive. The plate strengthening separated from the concrete, and there was visible damage to the NSM bonding adhesive.

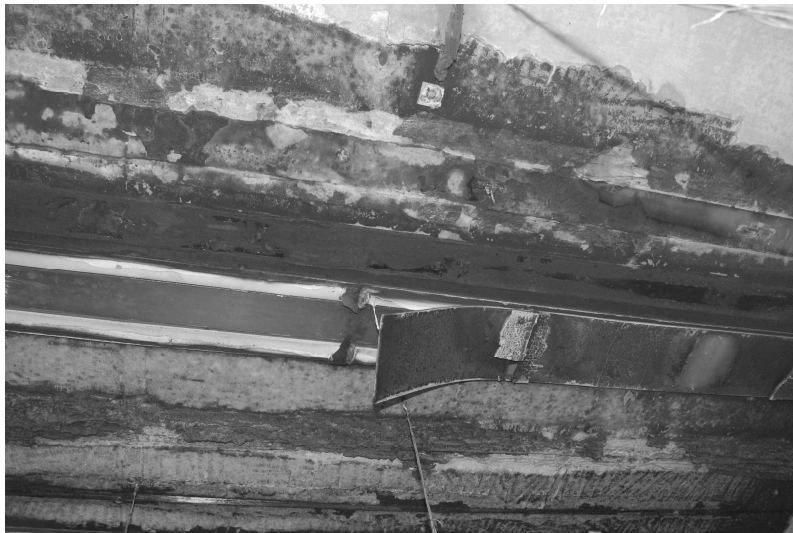
**Figure 5c: Gypsum-board-protected plate  
(protection removed after fire to expose plate)**

- The gypsum-board protection was inspected after the tests, and was fully intact. When the board was removed (Figure 5c), the plate was fully bonded to the concrete, and there was no *visual* damage to either the plate or adhesive.

The gypsum board protected the FRP strengthening from visible damage. However, the strengthening would not have been mechanically active during the test, due to the glass transition temperature having been exceeded.

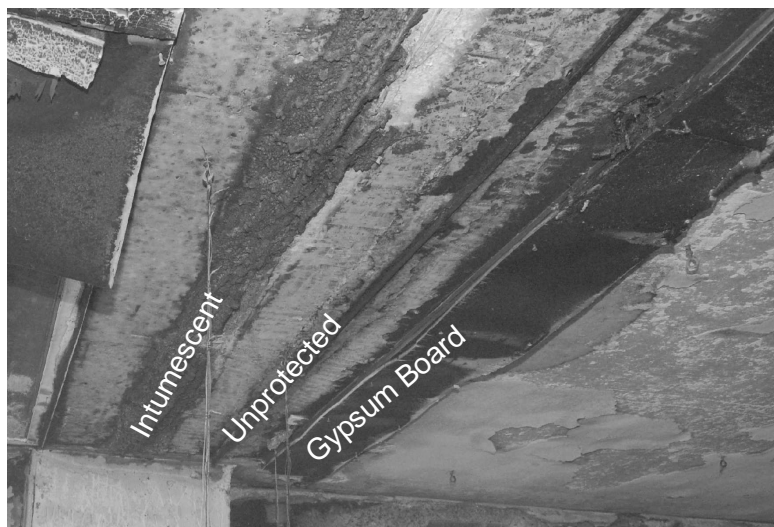
**Figure 5d: NSM strengthening after the fire.**

- The adhesive around the unprotected NSM bar (figure 5d) had burnt away, leaving the FRP exposed.
- The intumescent coating over NSM strengthening (figure 5d) had activated. The strengthening beneath the intumescent was in place, although the adhesive was glazed and contained transverse cracks.

- The gypsum-board protected NSM (figure 5d) remained intact, and the strengthening beneath was visually unaltered.
